DOMINION ENERGY SOUTH CAROLINA, INC.

Historic Structures and Visual Impact Assessment Report
for the

Toolebeck - Aiken 230 kV Tie
and Segments of the

Graniteville #2 - Toolebeck 230 kV
and Toolebeck - South Augusta 230 kV Tie
and
Associated Facilities

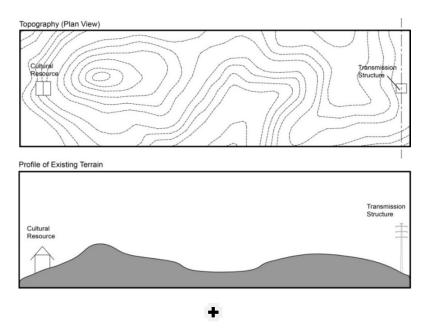
Figure 2: Topography

Using the information and data collected in Task 1, Pike created a digital model using ESRI's ArcGIS software. First, an existing grade terrain was created using topographical data (Figure 2). Aerial photography was then used to locate and extract visual obstructions in the study corridor; primarily mature vegetative cover (Figure 3). The obstructions in the form of ArcGIS polygons were extruded based on their estimated height off of the DEM, conservatively determined to be 60 feet, creating a single surface that now includes both topography and mature vegetative visual obstructions (Figure 4). This modified surface will provide the basis for assessing visibility from cultural resources to the Project Lines' route.

This report includes literary evaluations, mapping, photography, and line-of-sight profile graphs to clearly display any significant structures or places that may be impacted by a view of the proposed Toolebeck – Aiken 230 kV Tie, Graniteville #2 – Toolebeck 230 kV, and Toolebeck – South Augusta 230 kV Tie. Figures 2, 3, 4, 5 and 6 are included to graphically illustrate how Pike analyzed view probability from each historic resource by applying factors that included historic resource locations, transmission line structure locations (based on engineering assumptions), topography and vegetation, if any, between the resource and potential 230 kV transmission line structures. Figures 2, 3 and 4 illustrate how view analysis profiles are developed using topography and vegetative conditions present between viewpoints (i.e., specific historic resource locations) and proposed transmission line structures for the purposes of analyzing how views from the resources in the direction of the proposed transmission line are affected by the combination of landforms and vegetation. Figures 5 and 6 graphically depict how computer analyses, based on line-of-sight from the resources to proposed transmission line structures, are completed using the information developed from analyzing the topography and vegetative cover present between the resource and proposed transmission line structures.

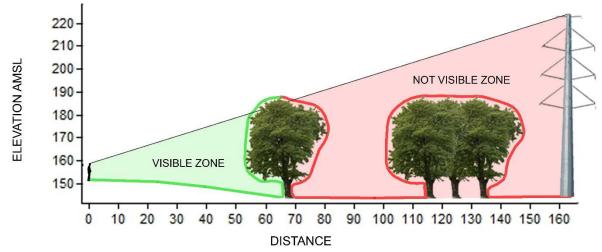
Figure 6: Profile Graph Example (Visualization)

Probable Visible Terrain/Vegetative Surfaces from the Viewpoint

Probable Not Visible Terrain/Vegetative Surfaces from the Viewpoint

- Viewpoint at the Resource
- Screening Element (Terrain or Vegetation) on the Line-of-Sight From the Viewpoint to the Top of Line Structure
- Top of Line Structure Seen
- Top of Line Structure Not Seen

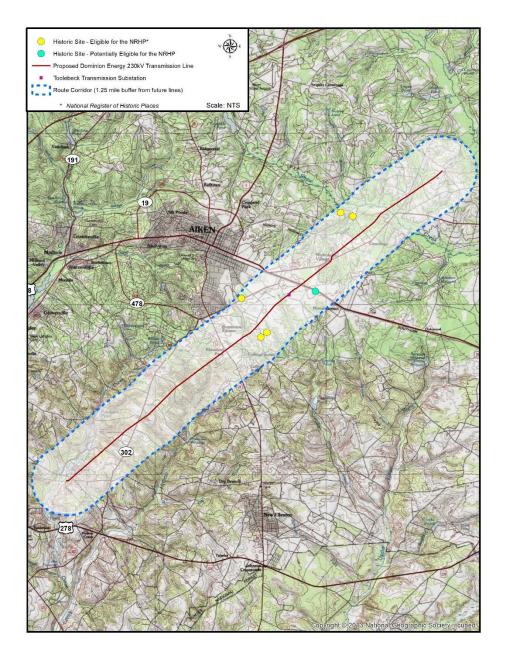
Figure 7: Historic Resource Vicinity Map

Figure 7 shows the project location, including the study corridor that extends outward 1.25 miles from the proposed Project Lines' route, over United States Geological Survey (USGS) topographic mapping. Overlaid on the mapping are the locations of the historic resources that are evaluated in this report. Figures 8, 9, 10, and 11 are enlarged segments of mapping showing the locations of the historic resources in relation to area roads, railroads, county boundaries and major water bodies.

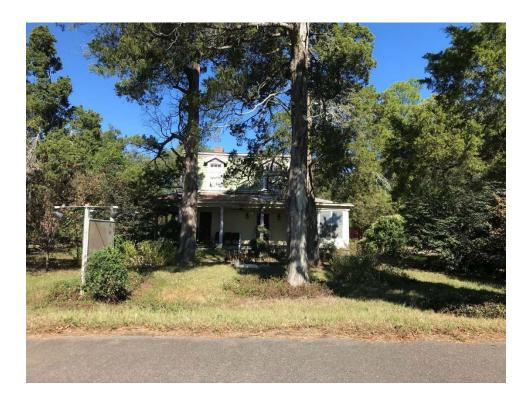
Profile Graph: Jack Lynes House (#005-2228) Elevation AMSL (feet) 200 180 160 1,500 3,500 500 1,000 2,000 2,500 3,000 4,000 4,500 5,000 5,500 Distance (feet)

Field Visit & Analysis: Though the resource faces the Project Lines' route, it was determined that it would not have a probable view of the Project Line's route from the house or yard area due to heavy foreground screening from scattered vegetation, nearby commercial development, and areas of heavy midground vegetative screening mixed with agricultural fields. In addition to the foreground vegetative screening, the resource is situated along the commercial corridor of E Pine Log Road, which is highly modified by retail buildings, restaurants, and overhead electric utilities.

Distance from Lines' Route: 5,670 ft.

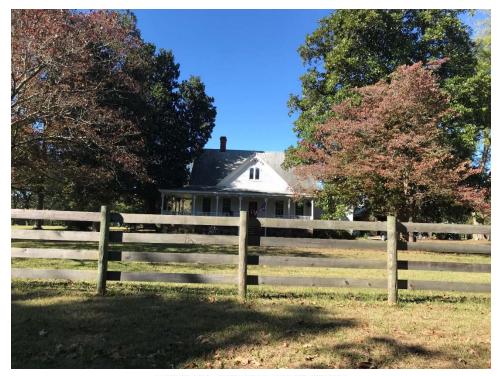
Profile Graph: Laurens Farm (#0257)

<u>Field Visit & Analysis:</u> The resource is a circa 1870 farmhouse surrounded by equestrian-related activities and is nestled within a historic setting of mature specimen trees. In addition to the foreground screening present on site, additional midground screening of mature forests limit potential views of the Project Lines.

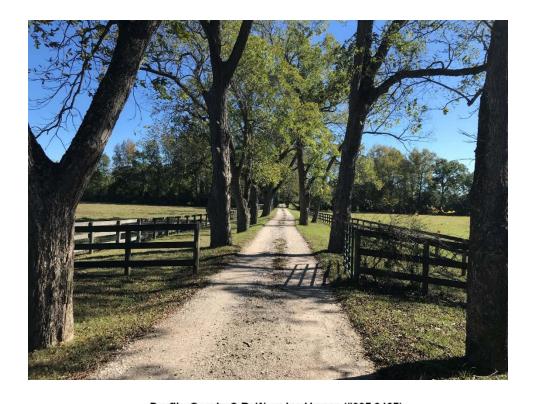
Profile Graph: C.B. Woosley House (#005 0465)

<u>Field Visit & Analysis</u>: The allée of trees to the residence and the dense grove of trees were the residence is situated have been preserved and provide no views of the resource from Banks Mill Road SE. The mature forests also provide significant and effective screening of the Project Lines' route.

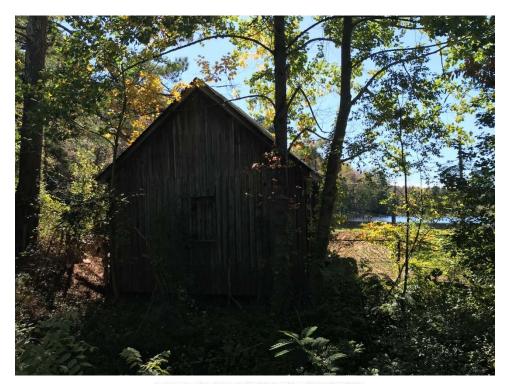
Profile Graph: Wright's Mill (#005 0461)

<u>Field Visit & Analysis</u>: Wright's Mill is a small wooden structure that is situated on the edge of a large pond and is largely surrounded by dense vegetation that is slightly interrupted by an existing South Carolina Public Service Authority (Santee Cooper) transmission line running along the southeastern edge of the millpond just under 0.25 miles away. Though the Santee Cooper line is visible, the existing DESC 115 kV line within the Project Line's route is not due to significant foreground and midground screening of mature forests.

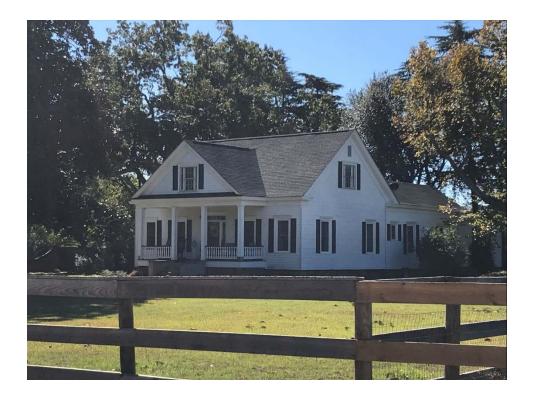
<u>Field Visit & Analysis</u>: The resource is located adjacent to a commercial business and is situated amongst a grove a mature specimen trees that significantly screen views in the direction of the Project Lines' route. Views of the existing 115 kV lines in the Project Line's route, and views of the future 230 kV Project Lines are only evident from the adjacent Highway 78, which is more than 130 feet away from the property boundary, and 260' from the farmhouse.

Conclusion: Views from the resource are not likely, and thus, no visual impact.
